Engineering Geomorphological Assessment and Slope Hazard Identification of the Haast Pass Highway Corridor

State Highway Six, Haast Pass, New Zealand

Master of Science in Engineering Geology

by
Andrew Timothy Walsh
2015

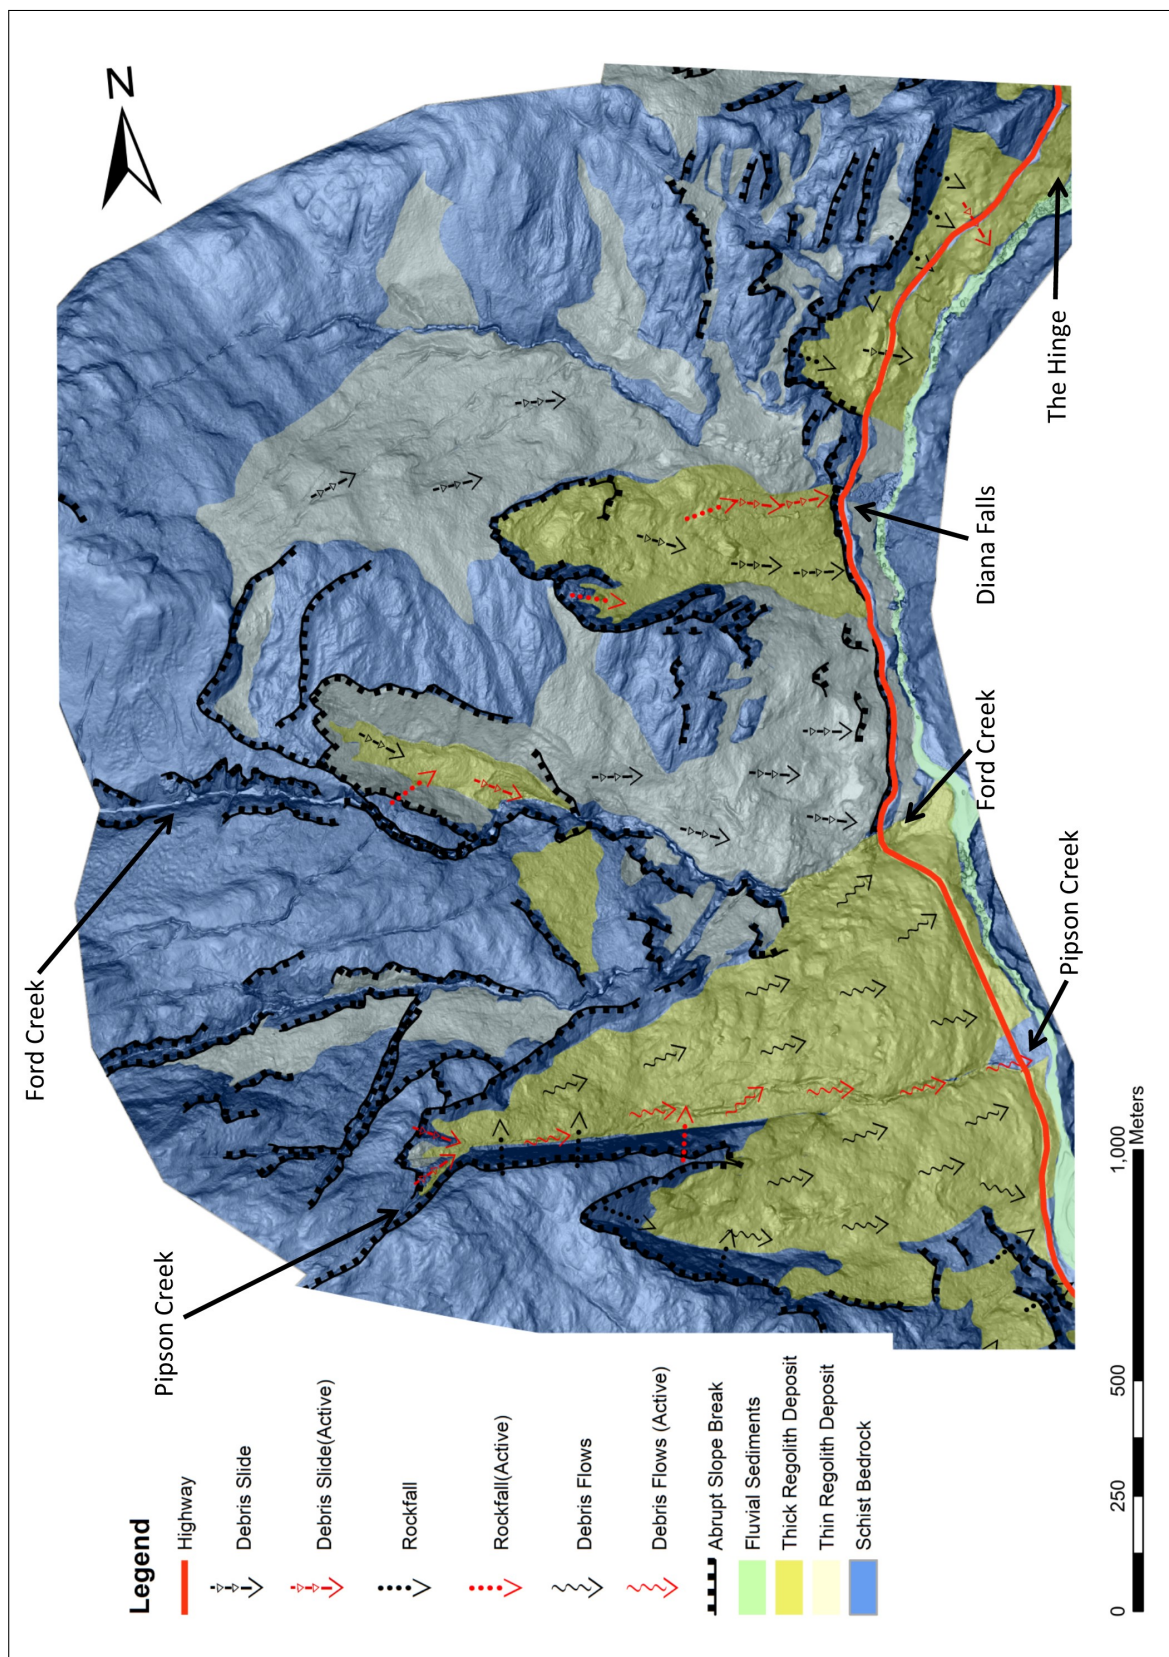
The slope above the highway between Ford Creek and Diana Falls is characterised by a combination of regolith and bedrock. The slope next to the highway largely consists of near vertical bedrock cliffs where the road has been cut into the slope. Above the bedrock cliffs next to the highway, regolith cover is variable on the lower and middle slopes and ranges from a thin cover to a very thick deposits of regolith. There are also some isolated patches of bare bedrock on the lower and middle slopes, but these are mostly confined to near vertical cliffs and one isolated area of predomi-

Figure 4.10: Geomorphology map of slopes above the highway between Pipson Creek and The Hinge.

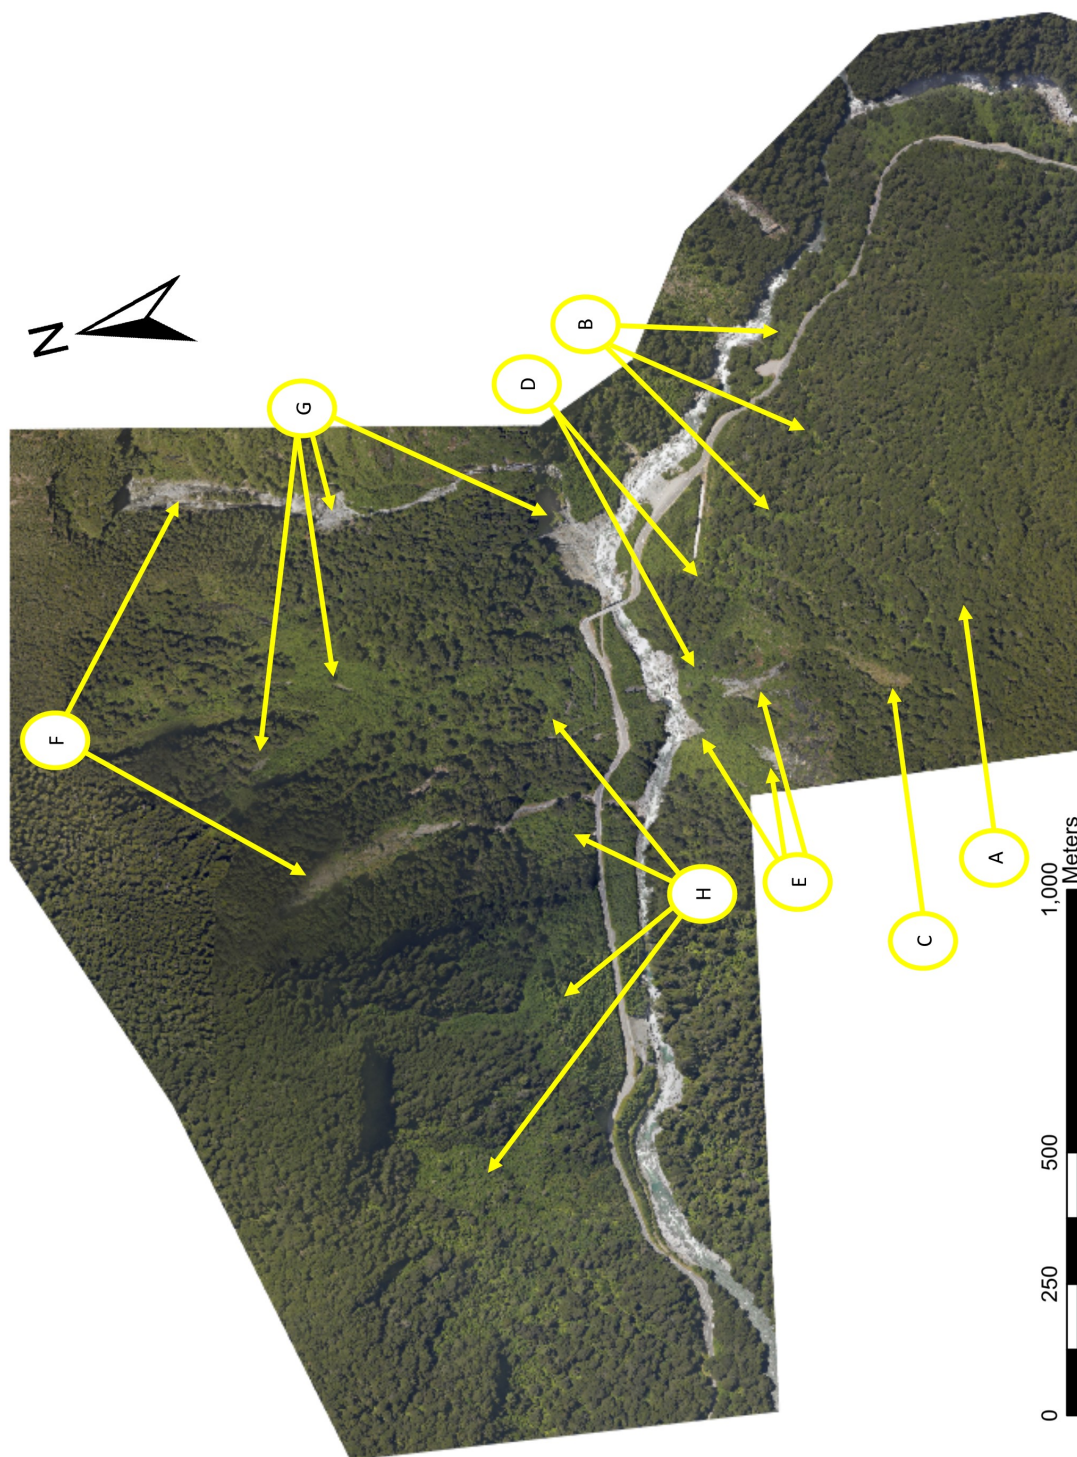
Aerial photo analysis of the slopes above the highway between The Hinge and the Gates of Haast Bridge shows clear indications of recent instability. Across most of the slope vegetation cover is very thick with mature trees visible in the aerial photo as the dark green coloured vegetation (Figure 4.11 A). While most of the slope is covered by mature dense vegetation there are areas where younger vegetation is visible. The young vegetation appears as the light green areas that are lower than the surrounding darker vegetation (Figure 4.11 B). This variability in vegetation maturity indicates that mass movement processes have likely been active in the recent past resulting in the removal of the more mature trees. An example of a recent landslide is visible as the light brown coloured area in Figure 4.11C where a debris or tree slide has removed vegetation. Based on the variations in vegetation maturity it appears that the slope above the southern approach to the bridge has been most active with larger areas of young vegetation compared with the slopes closer to the hinge (Figure 4.11 D). The dense vegetation on the slope made direct observations of the surface materials from aerial photography impossible with the exception of the slope below the bedrock cliff where regolith deposits are visible at the base of the cliffs and next to the river (Figure 4.11 E).

Figure 4.11: Aerial Photo of slopes above the highway between The Hinge and Thunder Creek Falls Car park. (A) Dense vegetation in the aerial photo appears as dark areas. (B) Patches of younger vegetation appear as the lighter green colours that appear lower than the surrounding vegetation. (C) Recent landslide where vegetation has been removed exposing schist rock. (D) Larger areas of younger vegetation appear near the highway bridge. (E) Areas where vegetation removal has exposed regolith. (F) Two areas where recent landslides and stream flow have exposed schist bedrock. (G) Areas of regolith material exposed beneath vegetation. (H) Very large areas of young vegetation on slopes above the highway west of Gates of Haast

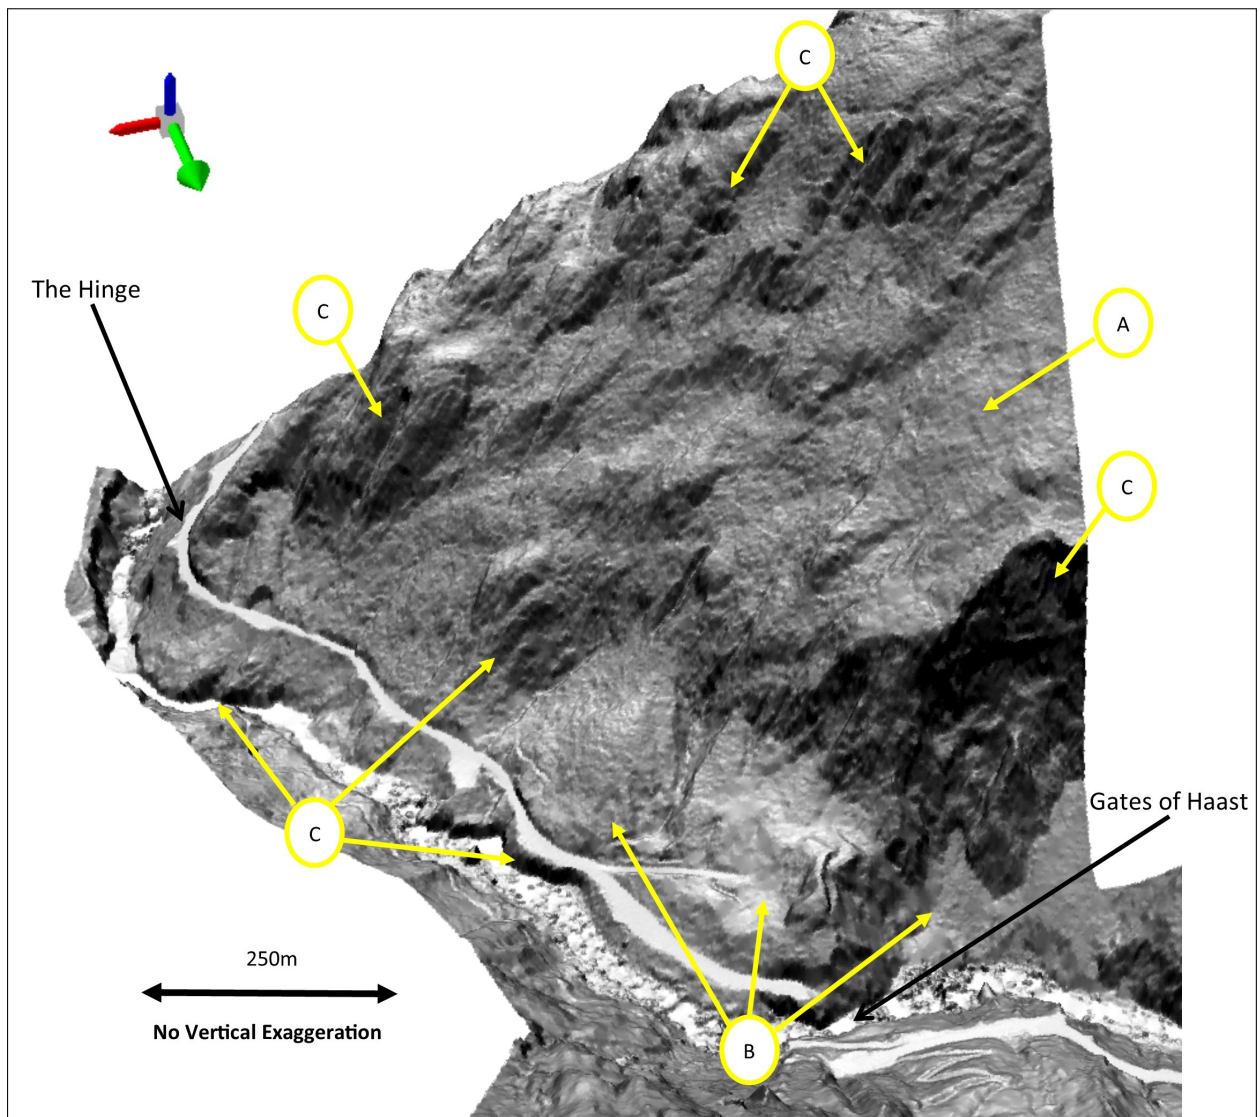
Figure 4.12: LiDAR model of the slopes between The Hinge and the Gates of Haast Bridge. (A) Rough undulating surface textures indicate regolith cover on upper slopes. (B) Larger deposits of regolith are present near the Gates of Haast Bridge. (C) Areas of bedrock identified by foliation lineations and the common orientation of cliff aspects.

LiDAR model analysis of the slopes between The Hinge and the Gates of Haast Bridge indicate that the slope consists of a mix of bedrock and shallow regolith cover. The slope consists of a rough undulating surface texture that covers the lower slope and the majority of the mid and upper slopes (Figure 4.12 A). The rough undulating surface textures are confined to the lighter coloured areas representing relatively gently slopes. The rough surface textures represent deposits of regolith on the slope and are relatively thin with the exception of the regolith cover in the vicinity of the Gates of Haast Bridge that is thicker (Figure 4.12 B). The steeper slopes represented by the dark shading are largely absent of the rough surface textures visible on the rest of the slope and in some cases lineations are visible on these surfaces (Figure 4.12 C). These steeper areas represent bedrock cliffs with surfaces are orientated approximately east-west, aligned with a prominent and persistent rockmass defect, with the lineations visible on the surface a result of schist foliation. Overall the slope is covered by a thin layer of regolith with bedrock exposed in steep cliffs on the slope and particularly below the highway next to the river.

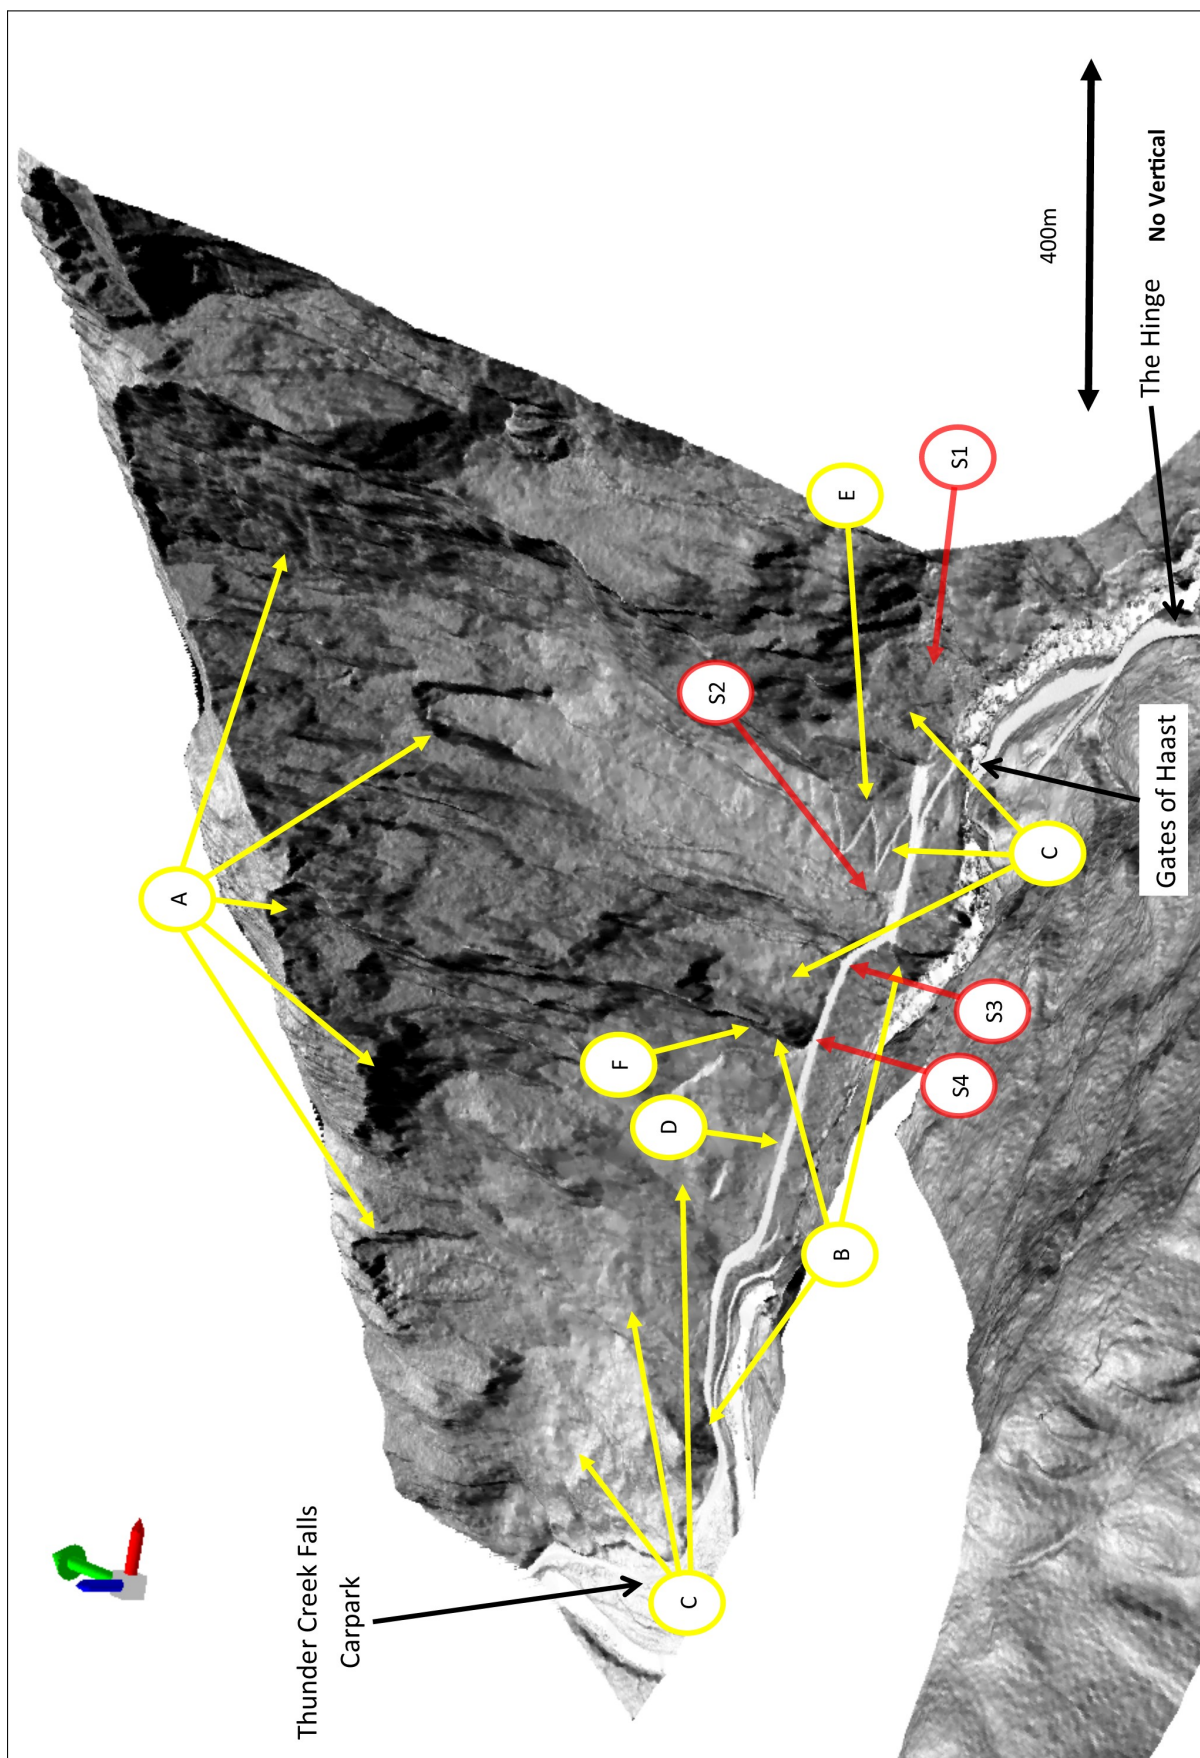
The slopes above the highway between the Gates of Haast Bridge and Thunder Creek Falls consists of a mix of bedrock and large deep deposits of regolith. The bedrock areas consist of steep cliffs shown as the dark areas in Figure 4.13A, but its the alignment of the cliffs that presents the clearest evidence that schist bedrock is exposed. The cliffs that are visible have a preferential orientation with surfaces striking north-south with surface aspects perpendicular to the slope. The preferential alignment of the cliffs is a result of bedrock foliation being the primary controller on the failure of bedrock and as a result the orientation of the cliffs. Using the bedrock textures it is clear that bedrock is present across most of the upper slope and in isolated areas in the mid to lower slopes where it is largely confined to narrow bedrock ridges(Figure 4.13 B). Next to and below the highway there is almost no bedrock exposed at the surface. Regolith cover is extensive across the lower slope with deposits extending into the mid slope but becoming thinner the higher up the slope they are deposited. The texture of the regolith cover in this area is very rough, undulating and irregular with the most significant deposits visible on the mid and lower slopes (Figure 4.13 C). The highway in this area is shown by the white flat surface running across the lower slope where it is almost entirely built on regolith (Figure 4.13 D).

Figure 4.13: LiDAR model Slopesshade of the slopes between the Gates of Haast Bridge and Thunder Creek Falls car park. (A) Areas of Bedrock identified by the linear cliff orientations and the regular undulations. (B) Small exposure of bedrock at the base of the slope dominated by the regolith. (C) Large thick deposits of regolith material covering the lower slopes. (D) State Highway Six cutting across the base of the slope over regolith deposits. (E) Zig zag pattern on this slope caused by a drainage track put in to divert the stream above. (F) Isolated ridge of schist bedrock on the lower slope. Ground truthing sites identified by the red arrows and S1, S2, S3, S4.

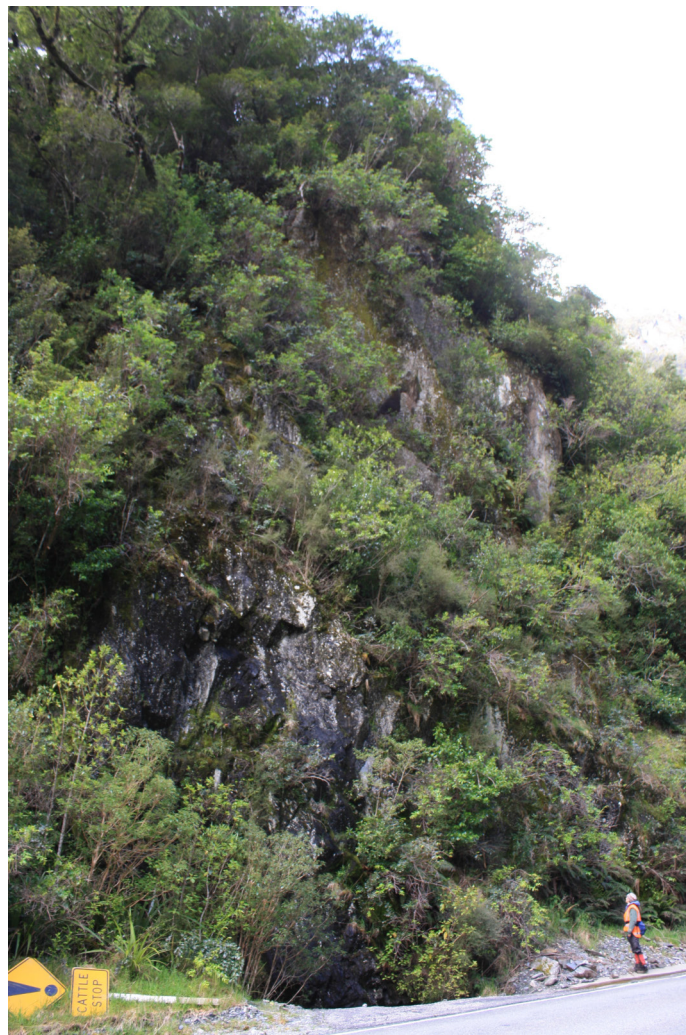
The final site that was investigated (S4) consisted of a large schist cliff next to the highway 400 metres west of the Gates of Haast Bridge. Analysis of the LiDAR model indicated that the slope in this area consisted of a ridge of schist rock flanked by deposits of regolith (Figure 4.13 F). Figure 4.18 shows an exposure of schist rock at highway level where the schist rock ridge in the LiDAR model meets the road. Measurements of the foliation orientations of the schist rock revealed a strike of 025 and a dip of 66 degrees matching the regional foliation orientation and indicating that this exposure of schist rock is an exposure of bedrock and not a large displaced block. On both sides of the bedrock outcrop schist boulders up to three metres across were just visible in the vegetation indicating that a surface cover of regolith exists on both sides of the bedrock outcrop. The presence of bedrock at this outcrop supports the interpretation that the ridge observed in the LiDAR model is bedrock and that both sides of the deposit consist of regolith materials.

Figure 4.18: SITE 4. Rockmass outcrop next to highway west of the Gates of Haast Bridge. Measurements of the foliation orientations of the rockmass revealed a strike of 025 and a dip of 66 degrees matching the regional foliation orientation and indicating that this exposure is schist bedrock.

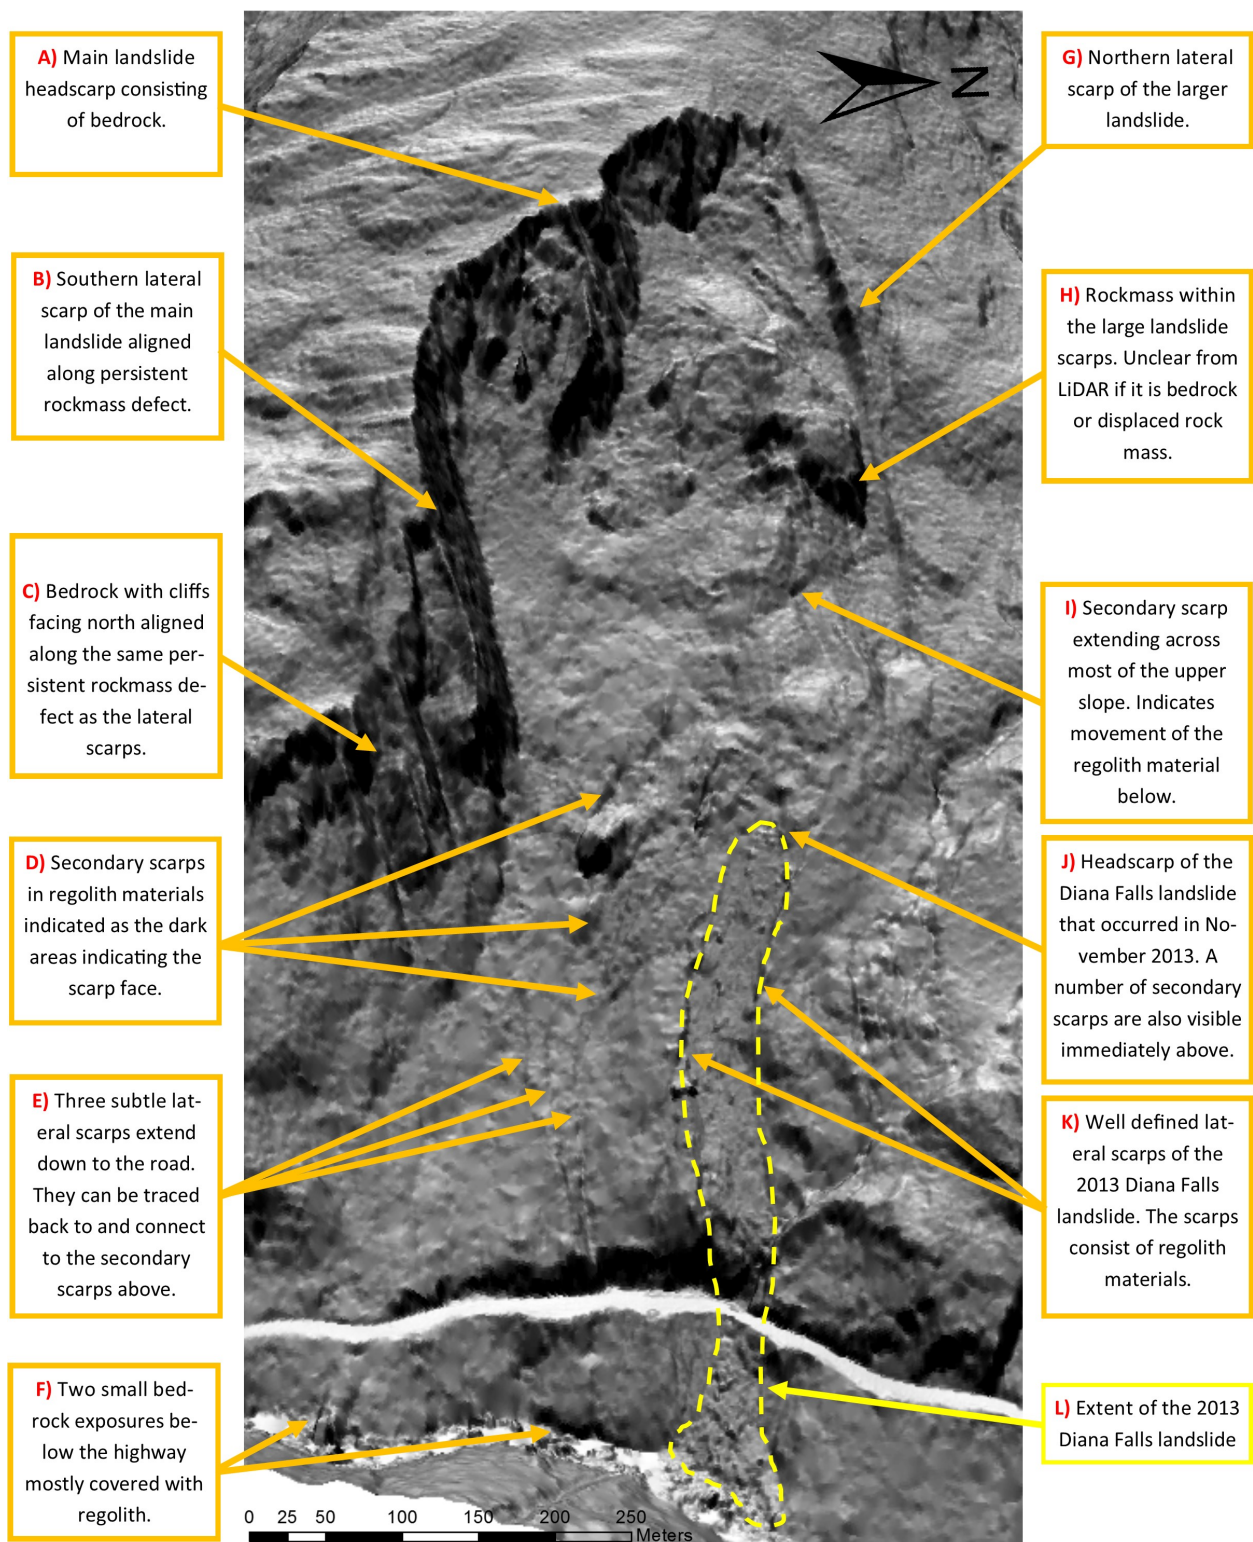
Small parts of the area around the Diana Falls landslide complex are composed of schist bedrock. Analysis of the LiDAR surface shown in Figure 5.2 revealed that foliation-aligned undulations located above the main landslide headscarp, and on the southern side of the southern lateral scarp. The headscarp (Figure 5.2 A) and southern lateral scarp (Figure 5.2 B) consist of steep cliffs of schist bedrock ranging from 20 to 100 metres high, with a number of parallel cliffs midway up the slope likely formed by a second persistent set of parallel rockmass defects (Figure 5.2 C). Bedrock is also visible at road level where the highway has been cut into the slope, exposing numerous sets of foliation planes with foliation attitudes conformable to regional bedrock, and is visible in the LiDAR surface as the very dark areas next to the bright highway. Within the confines of the large landslide scarps, exposures of bedrock are rare with only two locations where rock masses are identifiable. These are visible within the large landslide in the LiDAR surface (Figure 5.2 H) as a steep cliff near the top of the large landslide and another cliff just to the south of the Diana Falls Headscarp. The rock masses may be exposures of schist bedrock, but given that they are situated within a largely regolith covered slope and surrounded by landslide scarps it would be more realistic to consider them to be large displaced blocks of schist.

Figure 5.2: Oblique view of the LiDAR surface of Diana Falls landslide Complex with an orientation looking 270 degrees and 25 degrees from horizontal. Annotations indicate the major features visible on the surface of the slope. The

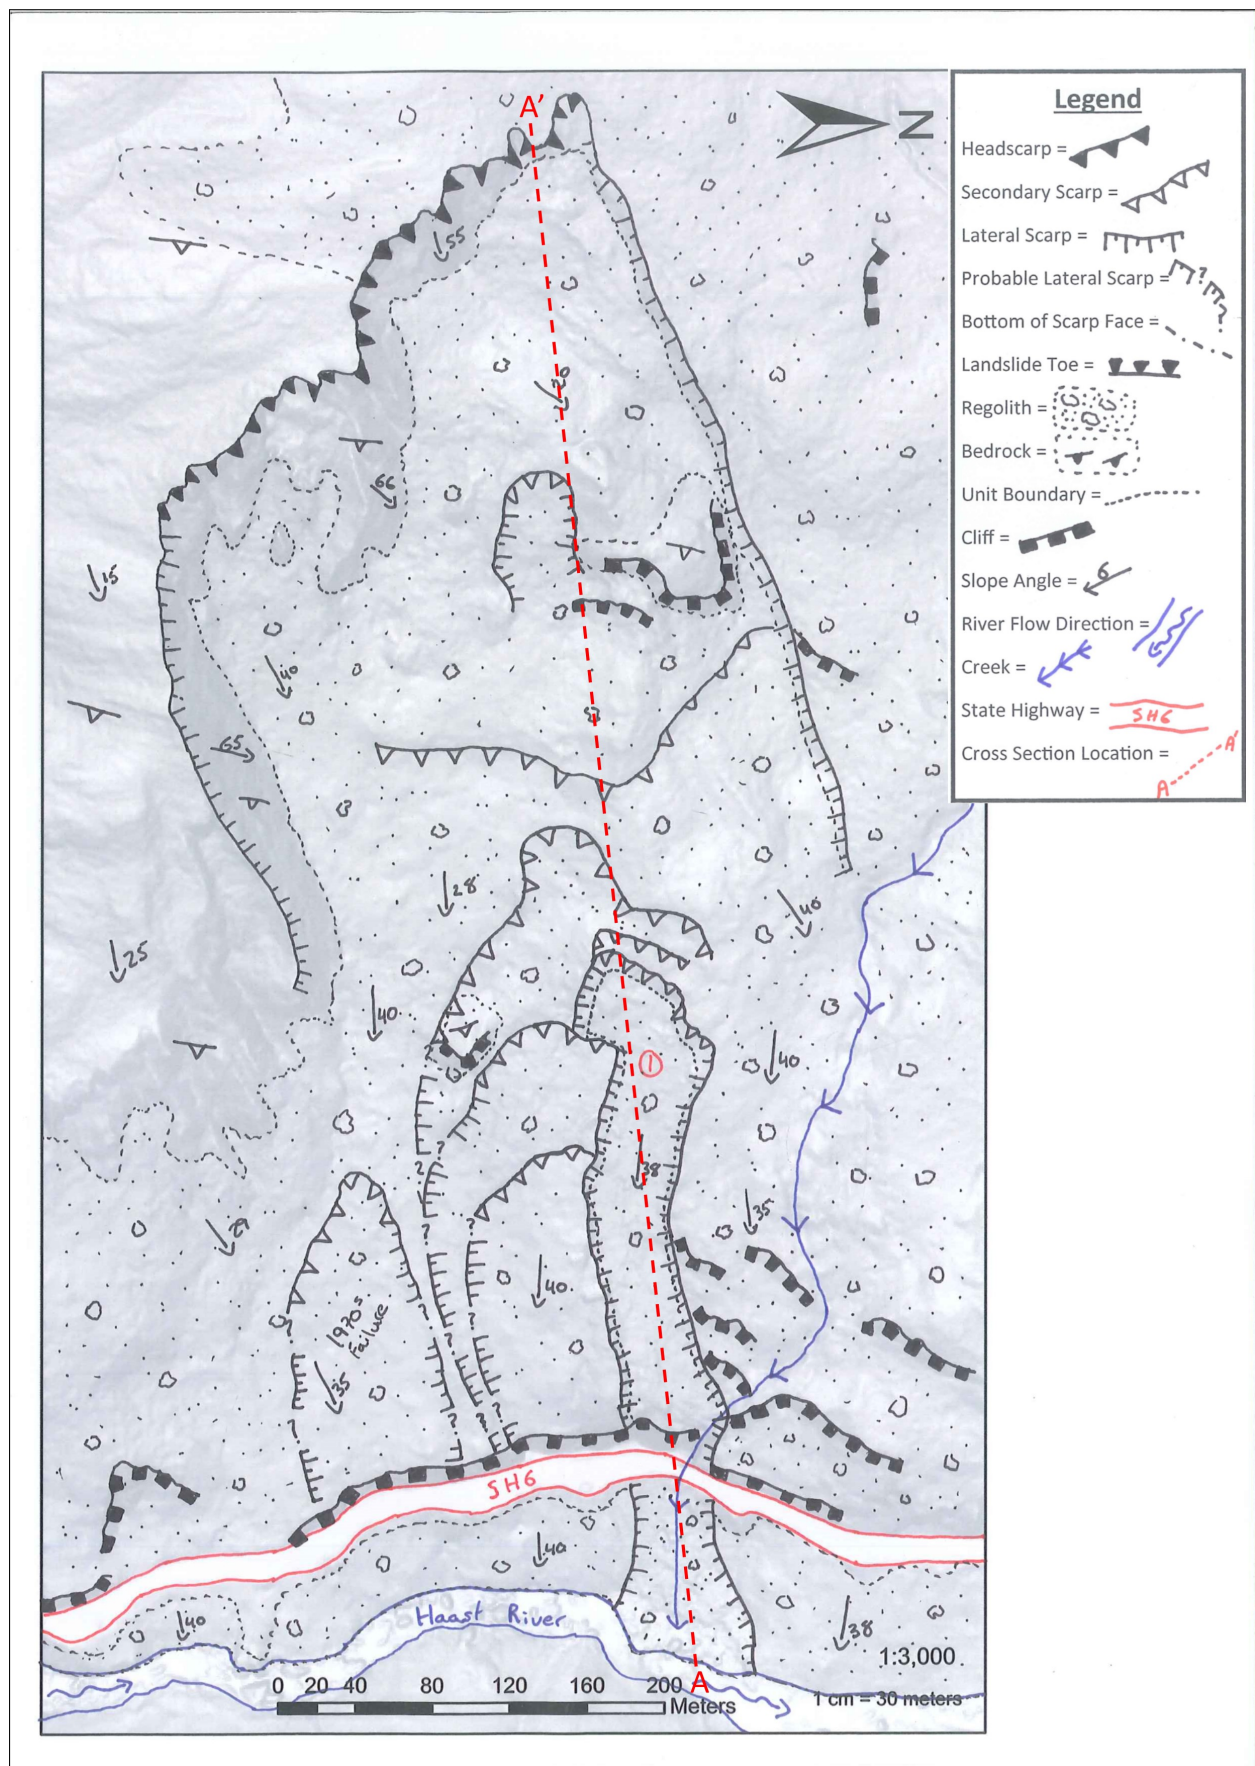
Figure 5.3: Engineering geomorphology map of the Diana Falls Landslide Complex showing the distribution of bedrock and regolith materials and landslide features.

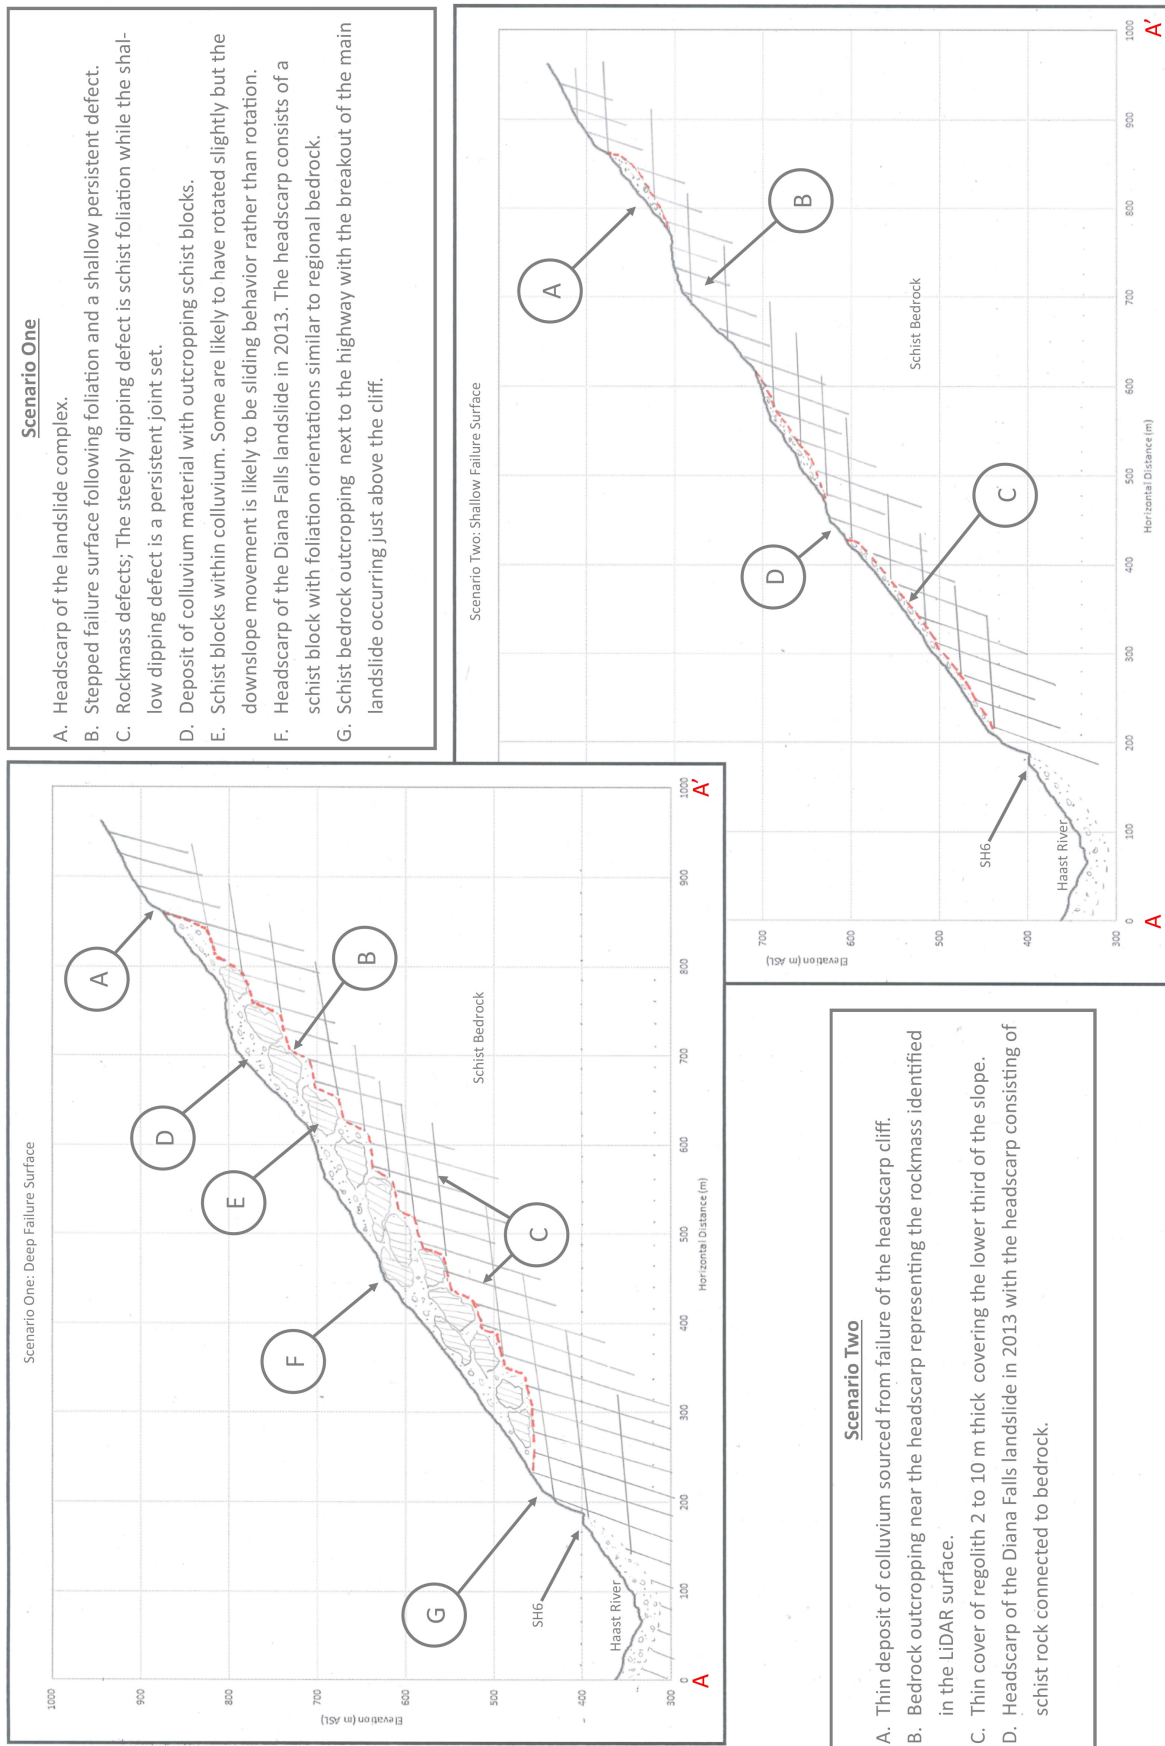
Figure 5.4: Diana Falls interpretative crosssections

The first scenario for the Diana Falls investigation area infers that the main landslide scarps are the result of displacement of a large landslide body with a deep failure surface (An interpretation of this scenario is shown as Scenario One in Figure 5.4). There are a number of rockmass defects within the schist bedrock that facilitate the failure; Three main persistent defects include foliation (dipping east at 70 degrees), defect one comprising the lateral scarps (dipping north/south and dipping near vertical) and defect two (dipping east at around 10 degrees). In this scenario foliation and defect two provide the basal failure surface with defect one acting as the third plane to facilitate failure. As a result of the basal failure surface following foliation and defect two the surface is stepped with large schist blocks being displaced and sliding down slope. In this scenario the large rockmass observed at the top of the 2013 Diana Falls landslide is a large schist block that has slid down slope, but has not rotated and still has foliation orientations similar to bedrock. It is conceivable that total displacement of the blocks has been relatively small and that most blocks would still have foliation orientations similar to bedrock. Given the very large and continuous schist rockmass observed a highway level the failure surface probably outcrops above the highway cliff exiting along defect two at a shallow angle.

The second scenario for the Diana Falls investigation area infers that the regolith material covering the slope within the landslide scarps is thin and that the rock masses within are exposures of schist bedrock (This scenario is shown as scenario two in Figure 5.4). In this scenario bedrock is exposed at or very near the surface with failures controlled by rockmass defects resulting in relatively small scale sliding failures. This results in the build up of a thin cover of regolith down slope of the bedrock exposures ranging in thickness from five to ten metres. In this case the rockmass at the top of the 2013 Diana Falls landslide, and near the top of the slope are exposures of intact bedrock with the rest of the slope consisting of shallow bedrock.

There is considerable uncertainty involved with the extrapolation of landslide subsurface geometry from its surface expression. Complete understanding of the true nature of the landslide failure surface cannot be accurately determined without a subsurface investigation but it is possible to narrow down the range of probable scenarios. It is more realistic that the failure surface is closer to scenario one than scenario two given the context of the large landslide features and the highly disturbed nature of the material within. The only way to truly understand the nature of the subsurface is to undertake more complete surface mapping combined with a subsurface drilling programme, but until then the most realistic interpretation is a slope closer to scenario one than scenario two.

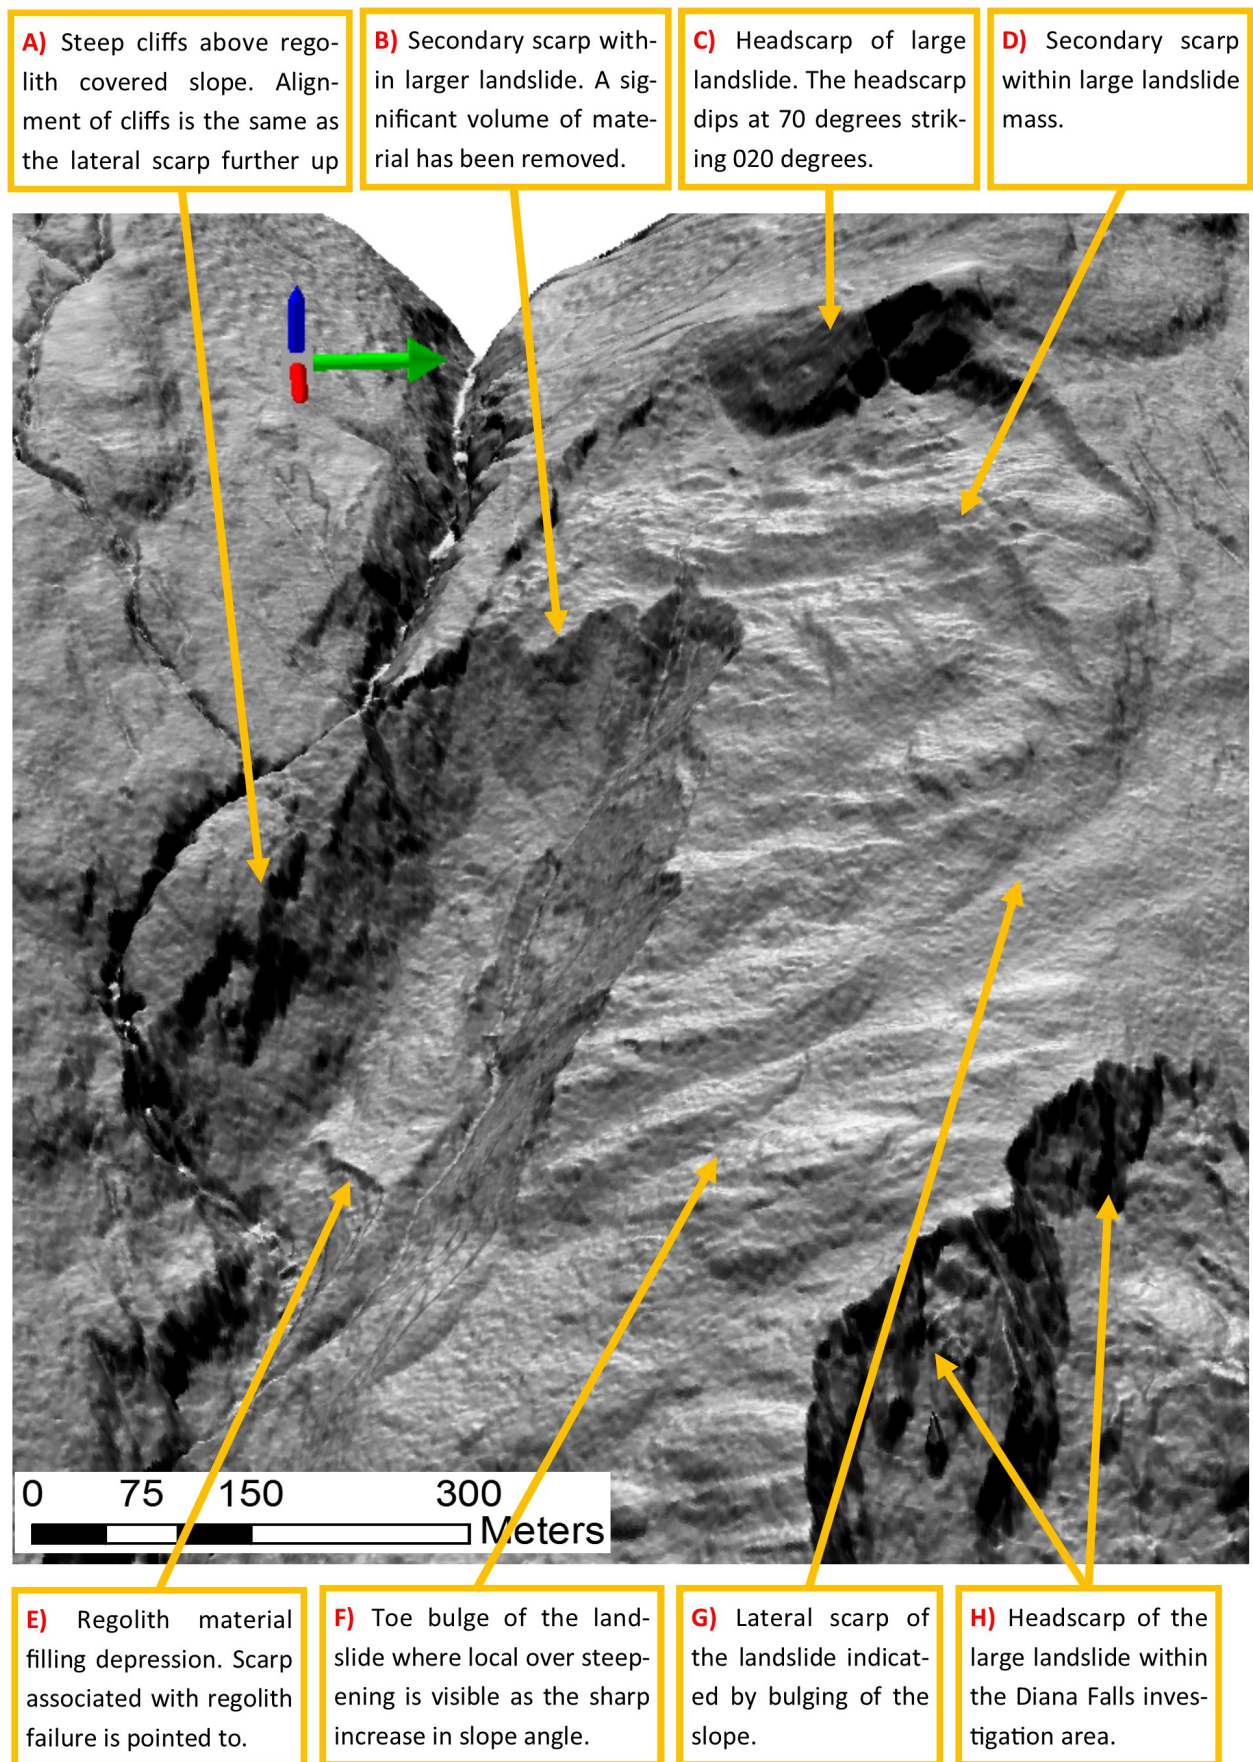
Figure 5.6: LiDAR slopeshade image of the Ford Creek landslide.

There are a number features in the LiDAR surface that indicate the presence of a large deep seated landslide on the slope just north of Ford Creek. The most prominent feature is the steep cliff at the top of the slope ranging in height from 60 to 80 metres in height (Figure 5.6 C). The headscarp

of the large landslide has failed along foliation defects as the surface of the cliff, striking approximately 020 degrees and dipping at about 70 degrees, follows regional bedrock foliation. On the northern and southern sides of the investigation area lateral scarps are clearly visible extending down from the headscarp with short steep bedrock cliffs marking the southern lateral scarp and a prominent surface undulation indicating the northern lateral scarp (Figure 5.6 G). The toe of the large landslide is identifiable on the northern side of the investigation area just above the large Diana Falls landslide Headscarp (Figure 5.6 F); Its appearance in the LiDAR surface is more subtle than the headscarp and lateral scarps, and can be identified by a sharp change in slope angle along undulations not parallel with the bedrock undulations. These features indicate that an area of bedrock of approximately 0.15km² has been subjected to a deep seated mass movement in the past and may still be actively creeping. There is also evidence that secondary mass movements of bedrock within the main body has also occurred.

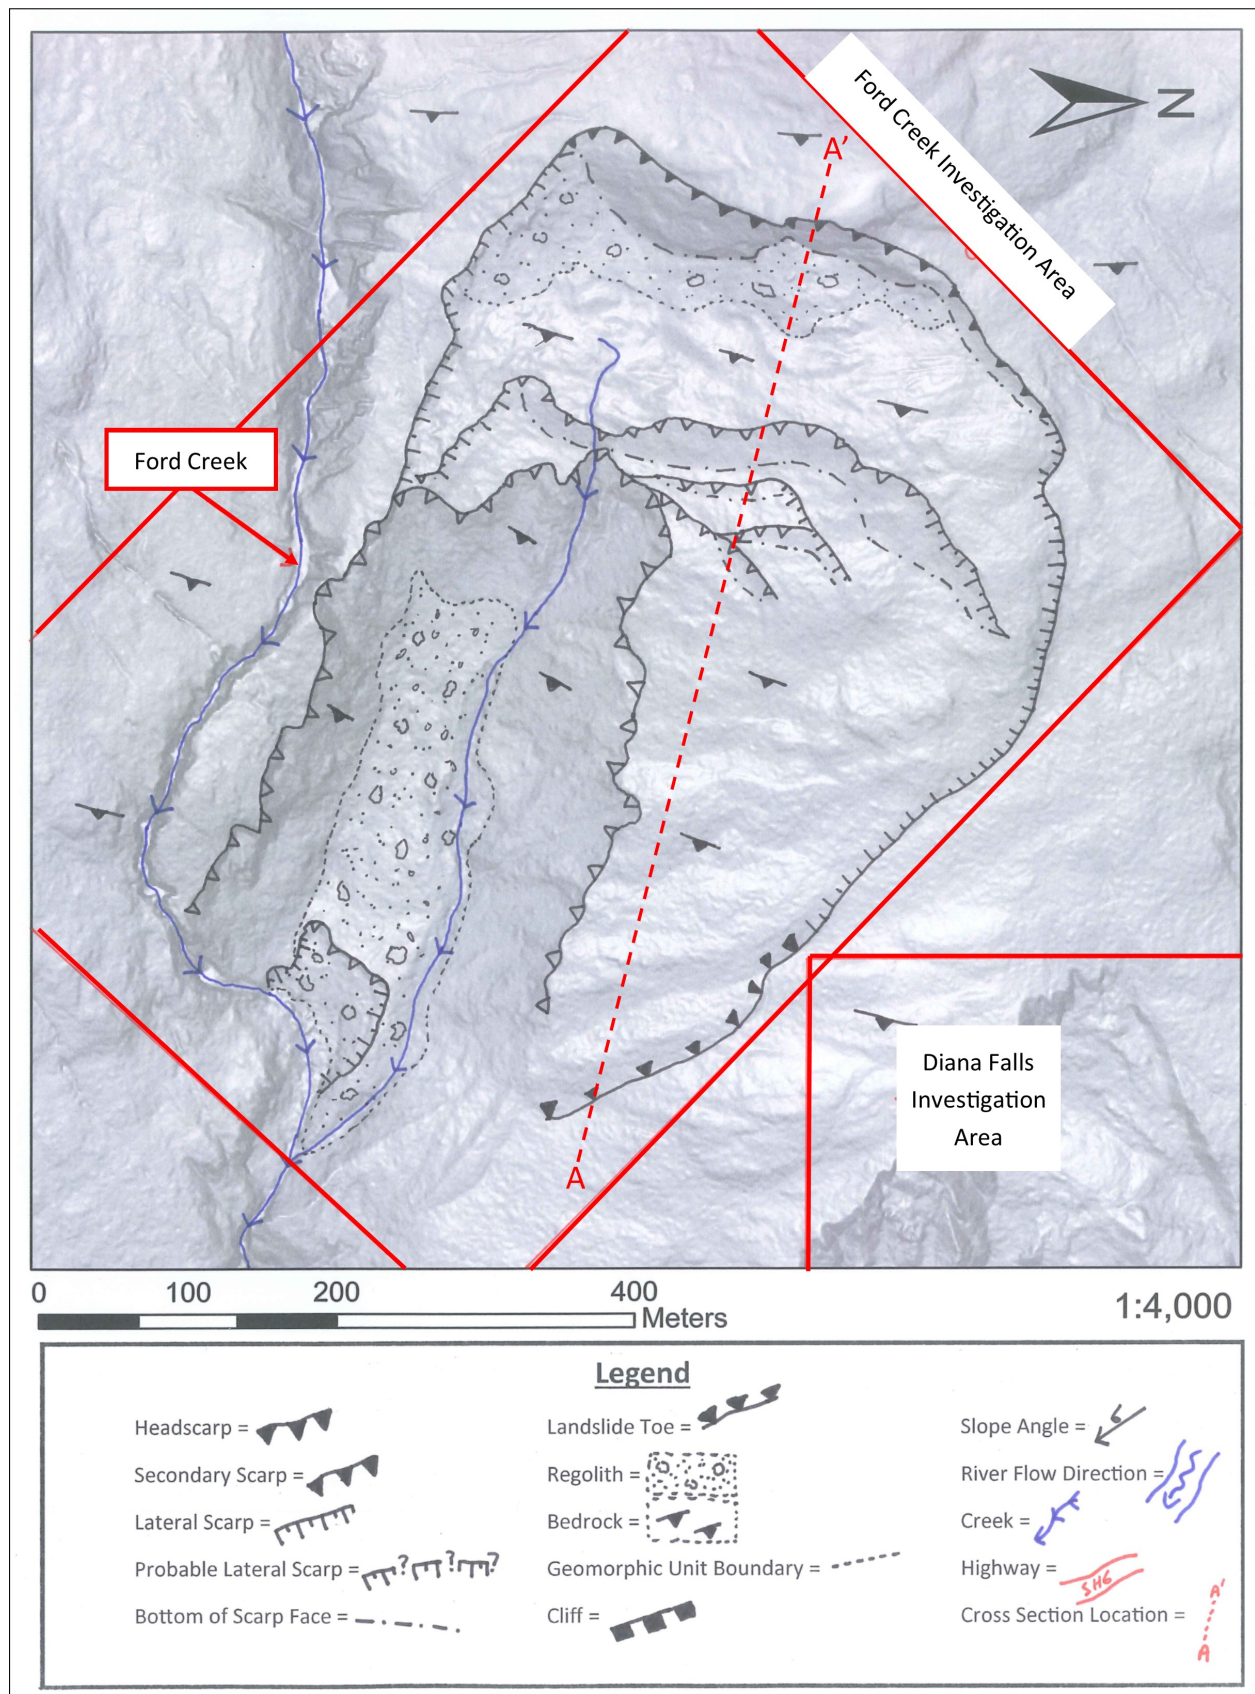
Figure 5.7: Engineering geomorphology map of the Ford Creek investigation area showing the distribution of bedrock, regolith materials and landslide features.
